Video Evaluation of Table Olive Damage during Harvest with a Canopy Shaker

Sergio Castro-Garcia¹, Uriel A. Rosa^{2,7}, Christopher J. Gliever², David Smith³, Jacqueline K. Burns⁴, William H. Krueger⁵, Louise Ferguson⁶, and Kitren Glozer⁶

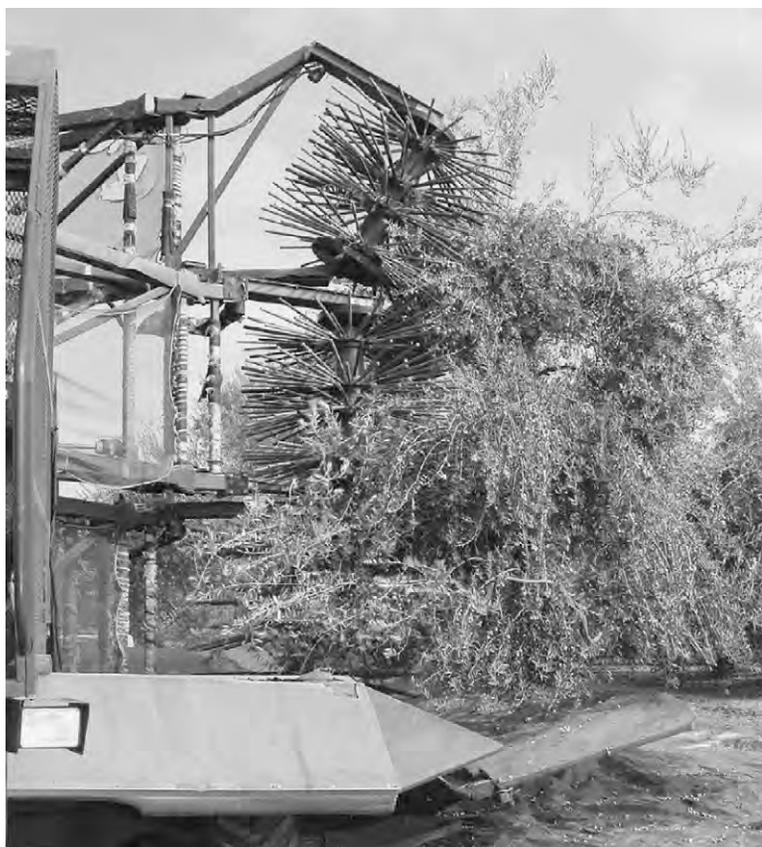
Fig. 1. Experimental olive canopy shaker used during tests on ‘Manzanillo’ table olives at the University of California Lindcove Experimental Station at Exeter in 2006. The harvester originated as an AgRight (Madera, CA)/Korvan (Lynden, WA)-engineered design prototype and has been modified by Dave Smith Engineering (DSE, Exeter, CA).

The Korvan/DSE harvester is designed to remove fruit by vibrating

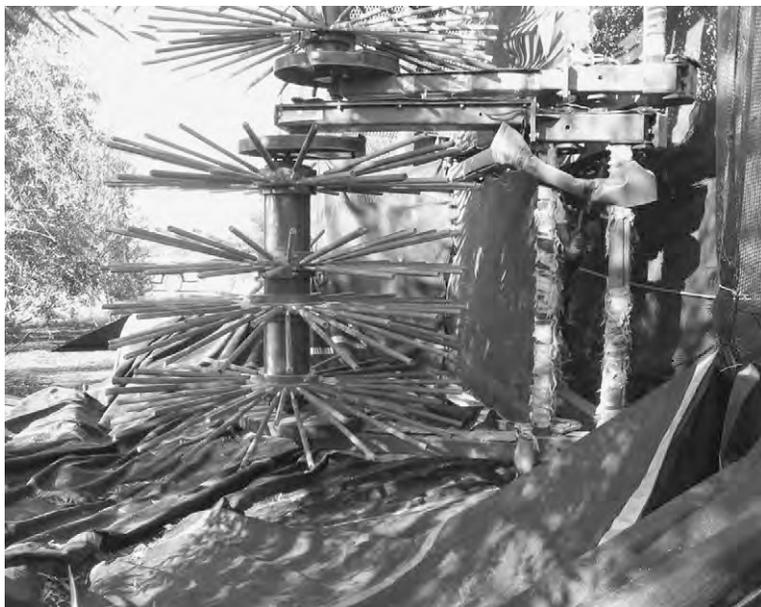
Fig. 2. Vertical drum and horizontal rod radial distribution set-up for the lowest drum of the olive canopy shaker used during experimental tests on ‘Manzanillo’ table olives at the University of California Lindcove Experimental Station at Exeter in 2006. The harvester originated as an AgRight (Madera, CA)/Korvan (Lynden, WA)-engineered design prototype and has been modified by Dave Smith Engineering (DSE, Exeter, CA).

the canopy with rods attached radially to the axis of three drums (Fig. 2). Drums are oriented parallel to the tree axis or at $\approx 45^\circ$ to the tree axis at the top of the tree. Rods penetrate the canopy on one side of the tree and shake with a predominantly oscillatory movement in the plane of the rods. While this movement is intended to remove fruit with little direct interaction between the rods and fruit, it is inevitable that rods, branches, and olives contact each other, causing mechanical damage to the fruit. Padding material encasing the rods is expected to reduce that damage; however, no documented analysis of the padding quality, or how it might be modified, exists.
