FIELD TEST RESULTS WITH MECHANICAL HARVESTING EQUIPMENT IN FLORIDA ORANGES

ABSTRACT. During the 1996-1997 season, mechanical harvesting tests were conducted with a canopy shaker, a trunk shake-catch harvester, and a fruit pickup machine. The canopy shaker, which moved continuously down one side of the tree row canopy, operated at 1.2 to 2.4 km/h. Orange removals ranged from 55% in larger diameter tree canopies to 95% in smaller tree canopies with machine capacities up to 25 t/h. The trunk shake-catch harvester removed 84 to 94% of oranges shaking 5 to 10 s per tree with machine capacities up to 10 t/h. The fruit pickup machine picked up oranges at 15 to 20 t/h at 97% efficiency and caused 3 to 7% split peels from handling.

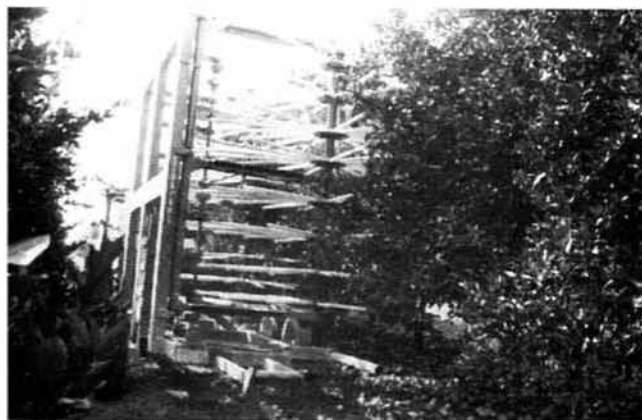
Figure 1—Rear view of USDA canopy shaker as operated in tests 1-4 without catchframe.

The USDA canopy shaker (Kearneysville, W.Va.) tested during the 1996-1997 season has been described by Peterson (1998). The design was a larger shaker (fig. 1) than the one tested during the 1995-1996 season (Peterson, 1998; Whitney, 1997). It had a catchframe and conveyors attached to deliver the collected fruit to the rear of the catchframe (fig. 2). The canopy shaker had two shaker drums with eight sets of 3.2-cm-diameter nylon spokes

Harvesting results are summarized in table 1. For tests 1-5 in early- and mid-season oranges, the spokes were 3.8 cm diameter and extended 1.5 m from the center of the shaft. Figure 1 shows the canopy shaker as used in tests 1-4 without a catchframe. The mature trees in tests 1 and 2 were similar and were planted on two-row beds with a ditch between beds. Fruit removal averaged 54% in test 1 and 56% in test 2.

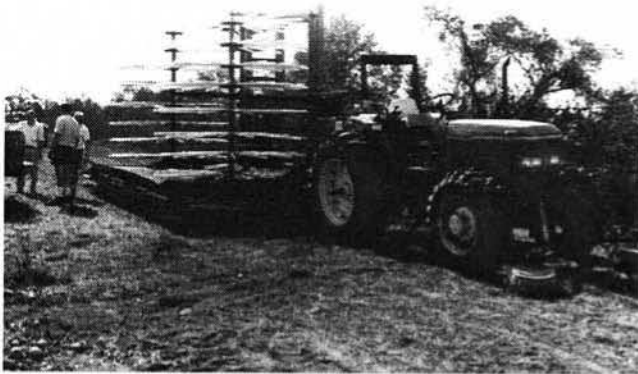
Figure 2—Front view of USDA canopy shaker with catchframe as operated in tests 5 and 6.

Test 5 was conducted after a January 1997 freeze and the effects of the freeze were fairly obvious on the small, young trees. Defoliation and fruit drop were heavy, and the fruit detachment force was only 26 N. The catchframe had been revised and mounted on the canopy shaker for this test (see fig. 2). The outside edge of the catchframe was operated about 15 cm from the trunkline (right side of machine) and limited the maximum reach of the spokes into the canopy to 15 to 30 cm from the trunkline. The tree canopies had been skirted to a height of 60 cm at the dripline and 45 cm at the trunk to accommodate the catchframe. Shaker fruit removal averaged 80%, and 27% of the fruit missed the catchframe and fell on the ground. There were no split fruit and the fruit burst force averaged 444 N.

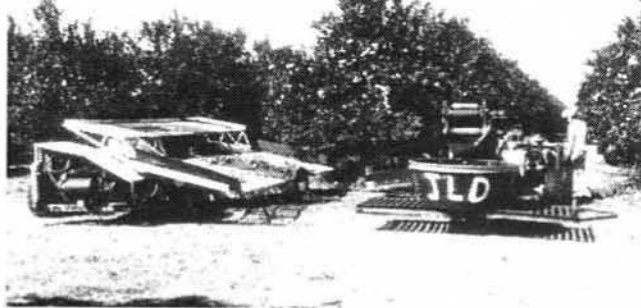
Figure 3—Rear view of Compton shake-catch harvester. Shake/deflector unit is at left of tree row and receiver unit is at right of tree row.

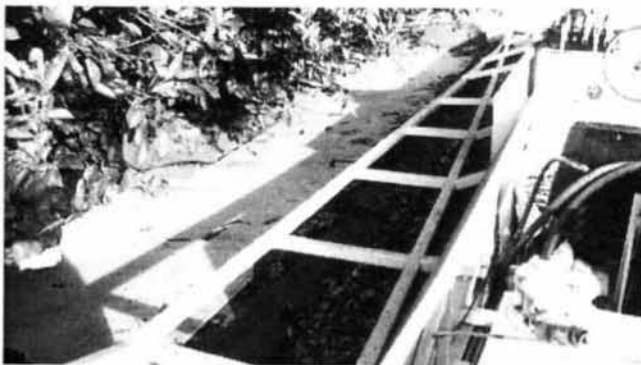
Figure 4—Rear view of Compton receiver unit. Dump pan is at left and longitudinal conveyor is at center.

pan 1.2 m wide \times 6 m long on the tree trunk side (fig. 4) to receive the fruit from the shaker deflector. Fruit was moved off the pan into the receiver unit longitudinal conveyor by elevating the pan edge nearest the tree trunk and pivoting about its opposite edge, and side shifting laterally toward the longitudinal conveyor. Fruit in the longitudinal conveyor moved to the rear of the receiver unit to a container (tub) on a roller platform which could be hydraulically raised and lowered. As the fruit was discharged from the conveyor into the tub, a fan blew trash out of the fruit. Three workers operated the system (shaker operator, receiver operator, tub handler).

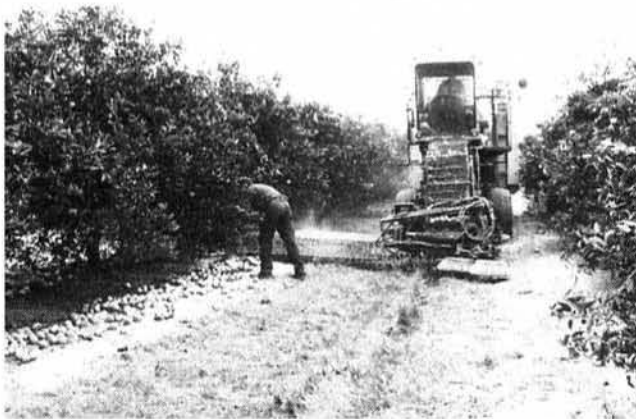
Figure 5—Front view of Agricultural Machines pickup machine as mounted on the Rhino® prime mover.

from the tree to the ground manually or by machine. It operated on one side of the trunkline so that two passes were required to pick up fruit from a tree row. Initially for the first field test, the pickup machine was mounted on a Rhino® prime mover (fig. 5). It was self-propelled with a pickup head and conveyors to move the fruit from the ground to a storage bin on the machine. A rod draper chain was used on the pickup head and conveyor system. As the machine moved forward, the pickup head chain moved laterally along the ground to pick up fruit in place to within 60 cm from the trunkline. The fruit was later transferred from the pickup head chain to other conveyors for delivery to the storage bin. The fruit was unloaded from the storage bin into a semi-tractor trailer with two vertical elevator conveyors mounted in one side of the storage bin.

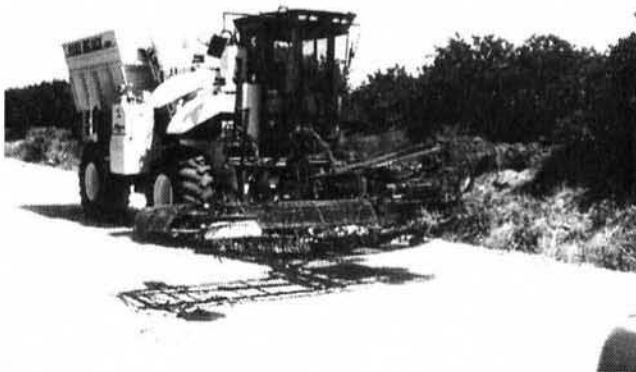
Figure 6—Front view of Agricultural Machines pickup machine as mounted on the Pixall Big Jack®.

For the second and third field tests, the pickup head was mounted on a Pixall Big Jack® (fig. 6). Fruit stored in the Big Jack® hi-lift storage bin was dumped into the semi-tractor trailer.

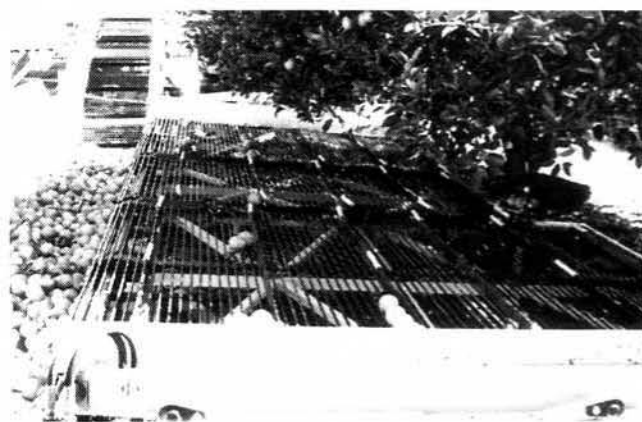
Figure 7—Front view of Compton rebuilt receiver unit showing cross conveyors at right which moved fruit to the longitudinal conveyor at left.

Prior to test 10, the receiver unit was returned to California and completely redesigned and rebuilt. The newly designed receiver unit utilized continuously running rod cross conveyors to move the fruit from the trunkline to the longitudinal conveyor (see fig. 7). Test 10 was conducted on Valencia orange trees on one-row beds. Each tree was shaken 5 to 7 s at 8 Hz with trunk circumference and clamp height averaging 51 and 23 cm, respectively. Mature fruit removal was 74% and the mature fruit to young fruit removal ratio averaged two with young fruit diameters ranging from 15 to 38 mm. The percentage of mature fruit which missed the catchframe (12%) was greater than in previous tests because the shaker/deflector unit and receiver unit could not properly position to get a good row seal where the two units overlapped in the trunkline. Shaking caused trunk bark damage on some of the trees.
